**UPSTREAM DAM
MADISON COUNTY, MISSOURI
MO 31080**

PHASE I INSPECTION REPORT NATIONAL DAM SAFETY PROGRAM

JUNE 1979

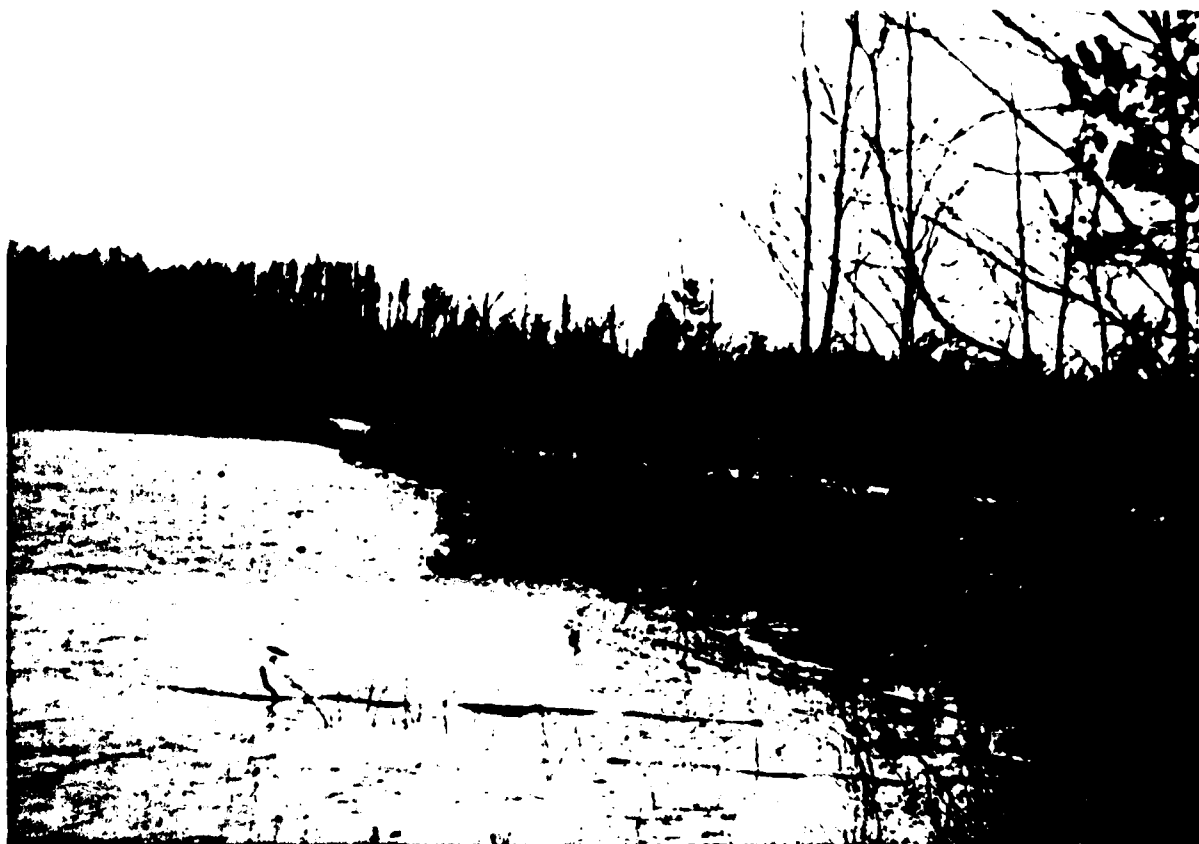
OVERVIEW OF THE UPSTREAM DAM AND RESERVOIR FROM RIGHT ABUTMENT
